# **Geotechnical Site Investigation Report for**

## **Lot 325-DP 244559, Driftwood Shores- Stage 1, Tuross Head.**

ASCT Reference Number: H22-195  
Prepared for McCloy Group

Re: \_\_\_\_\_  
Proposed residential subdivision.

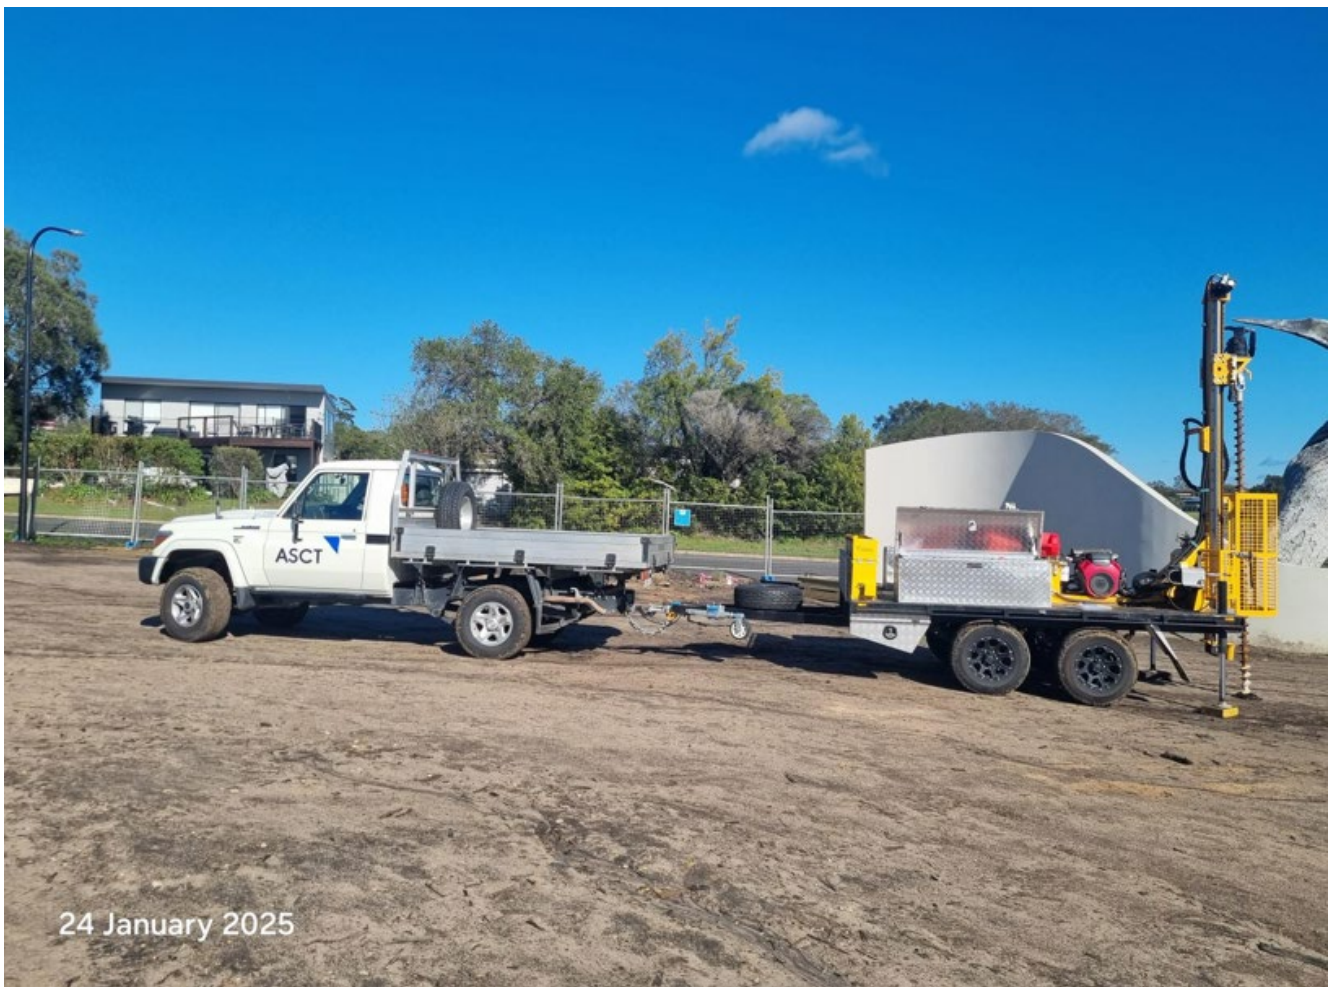
**View of the site .**
